[Docket No. FAA-2011-1158; Directorate Identifier 2010-SW-018-AD]

Airworthiness Directives; Eurocopter France Helicopters

ACTION: Notice of proposed rulemaking (NPRM).

EUROCOPTER FRANCE: Docket No. FAA-2011-1158; Directorate Identifier 2010-SW-018-AD.

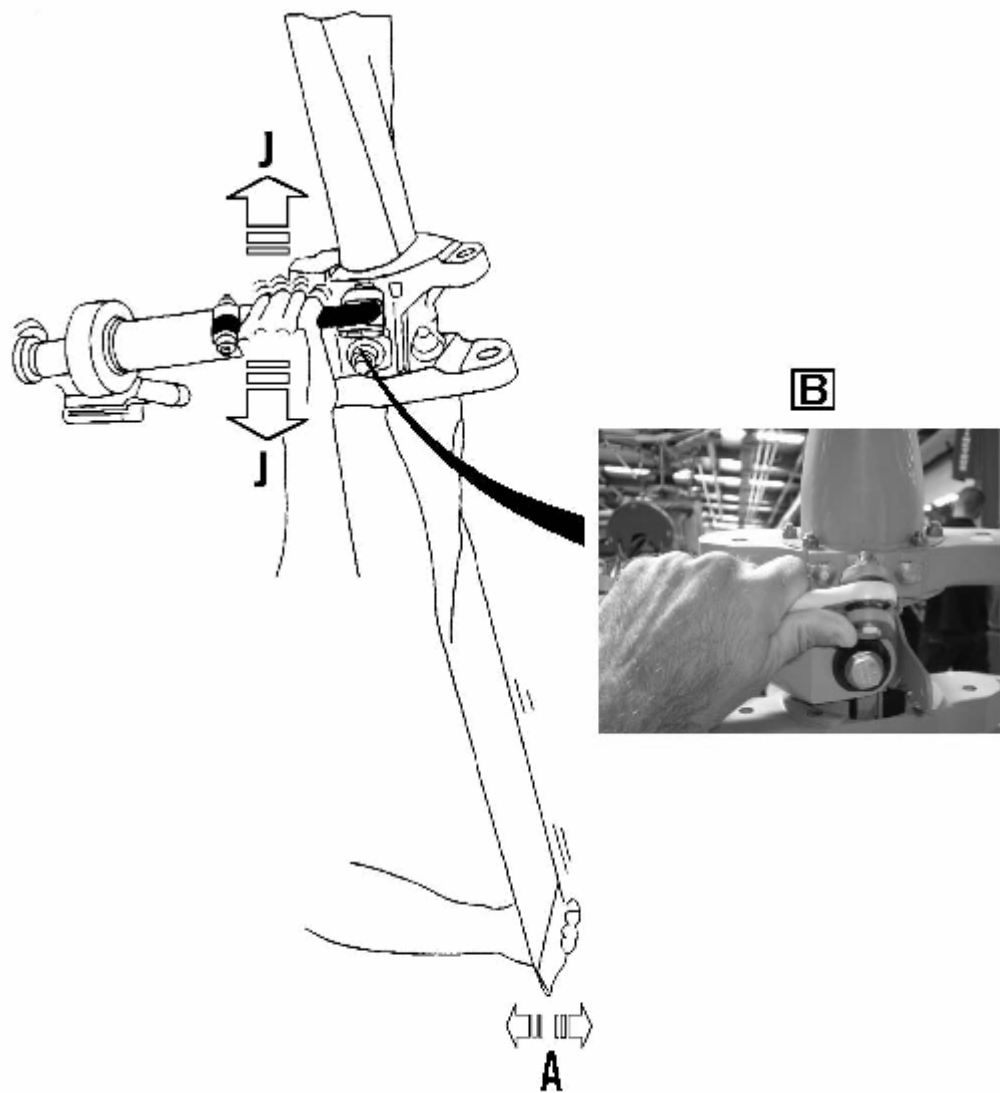
Manual Check for Play of the Tail Rotor Pitch Control Rod
Figure 1 to Paragraph (f)

intervals not to exceed 30 hours TIS, place the T/R pedals in the neutral position. If the helicopter is fitted with a T/R load compensator, discharge the accumulator as described in the rotorcraft flight manual. Check the control rod bearing (bearing) for play on the helicopter, by observation and feel, by slightly moving the T/R blade in the flapping axis while monitoring the bearing for movement. See the following Figure 1 to Paragraph (f) of this AD. The actions required by this paragraph of may be performed by the owner/operator (pilot) holding at least a private pilot certificate, and must be entered into the helicopter maintenance records showing compliance with this AD in accordance with 14 CFR 43.9(a)(1)-(4) and 14 CFR 91.417(a)(2)(v). The record must be maintained as required by 14 CFR 91.417, 121.380, or 135.439.

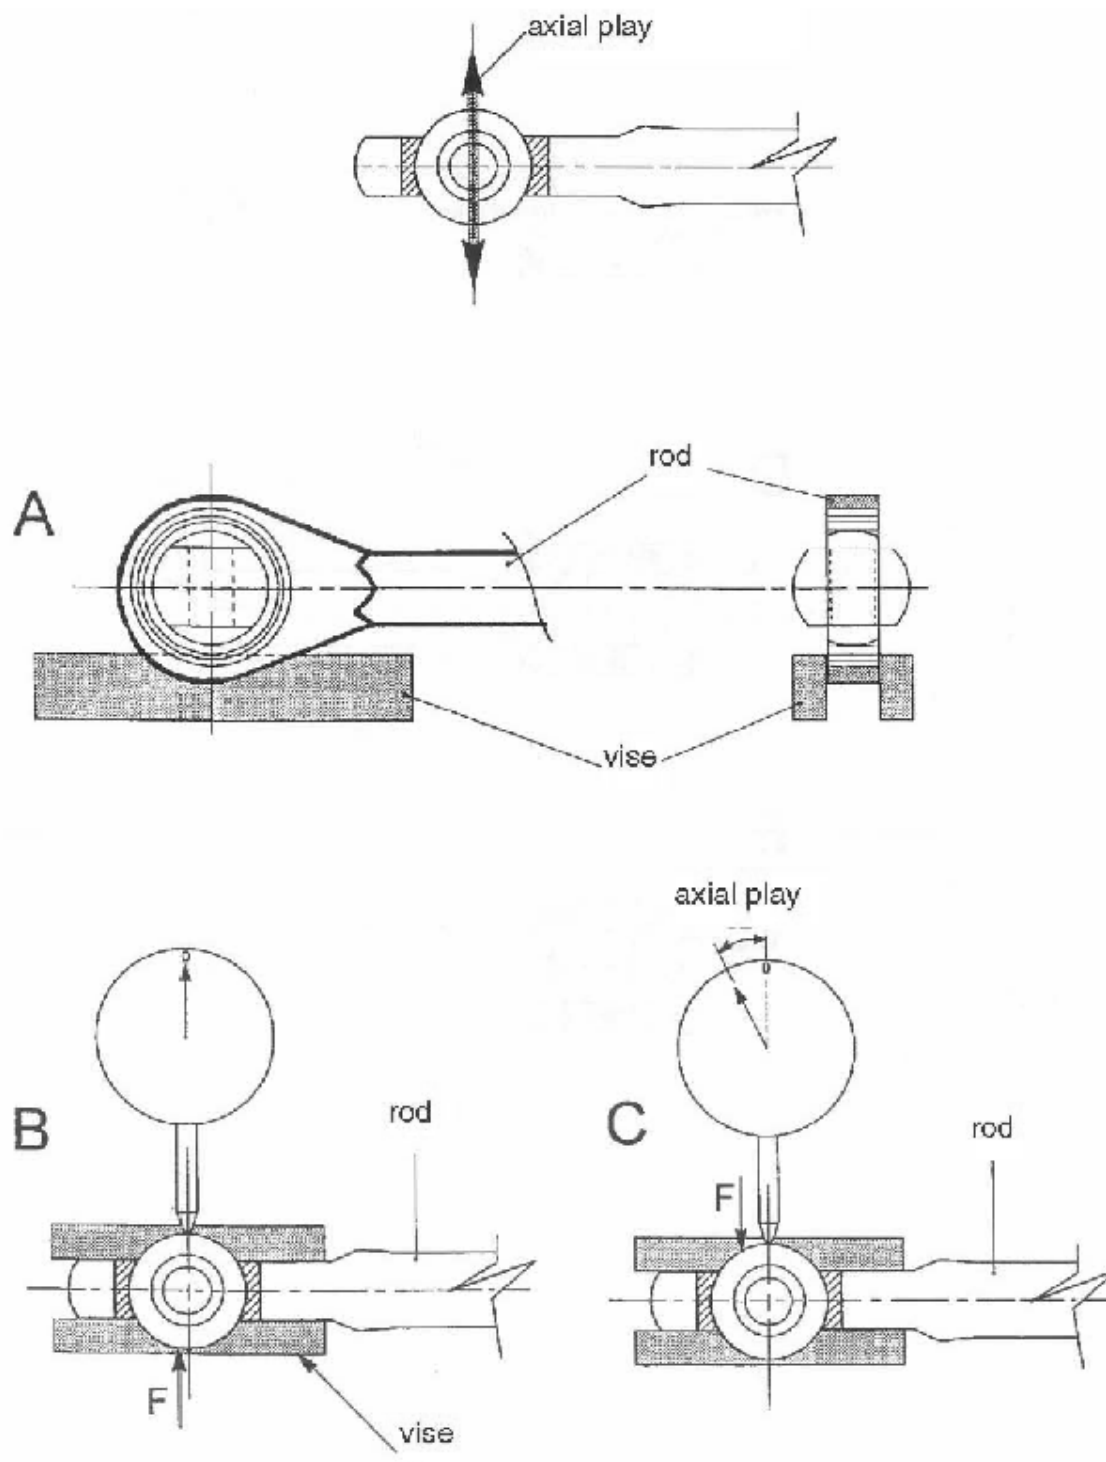
Measurement of the Axial Play (A) of the Bearing

- (i) Remove the control rod from the helicopter.
- (ii) Mount the control rod in a vise as shown in Figure 2 to Paragraph (f) of this AD.
- (iii) Using a dial indicator, take axial play readings by moving the spherical bearing in the direction F (up and down) as shown in Figure 2 to Paragraph (f) of this AD.

- (vii) Record the hours of operation on each control rod.
- (viii) If the radial play exceeds 0.008 inch or axial play exceeds 0.016 inch, replace the control rod with an airworthy control rod before further flight.

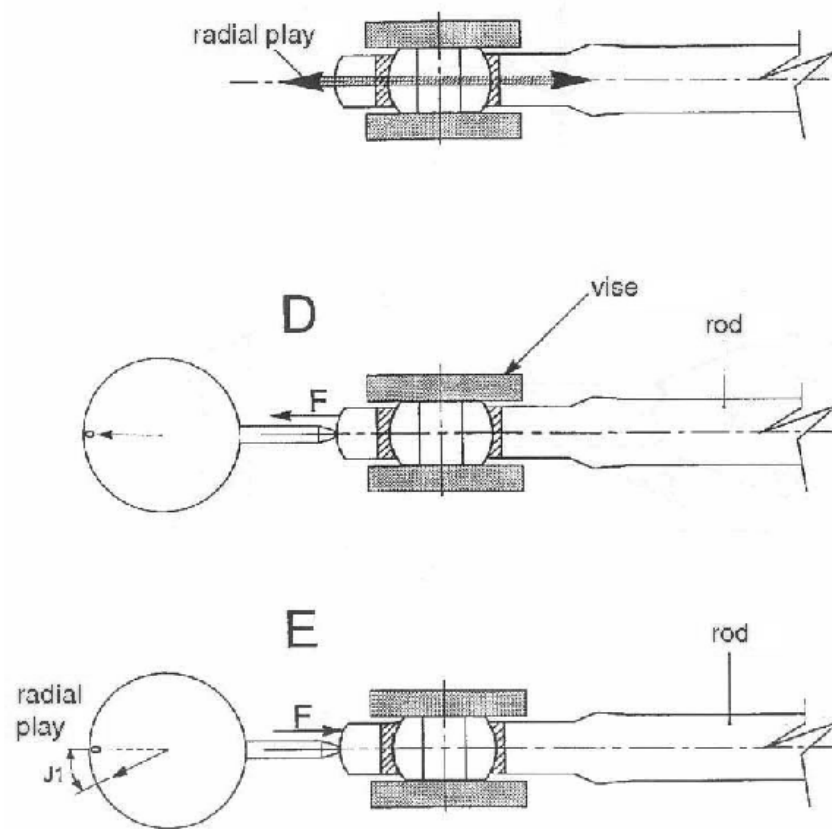
Figure (3) to Paragraph (f)

Measurement of the Radial Play (R) of the Bearing

- (iv) Install a bolt through the bearing and secure it with a washer and nut to provide a clamping surface when the bearing is clamped in a vise.
- (v) Mount the control rod and bearing in a vise as shown in Figure 3 to Paragraph (f) of this AD.

- (vi) Using a dial indicator, take radial play measurements by moving the control rod in the direction F as shown in Figure 3 to Paragraph (f) of this AD.
